AiGO Field Notes 2017-03-11

如何更新 ASI 034, ASI120MM/MC 韌體

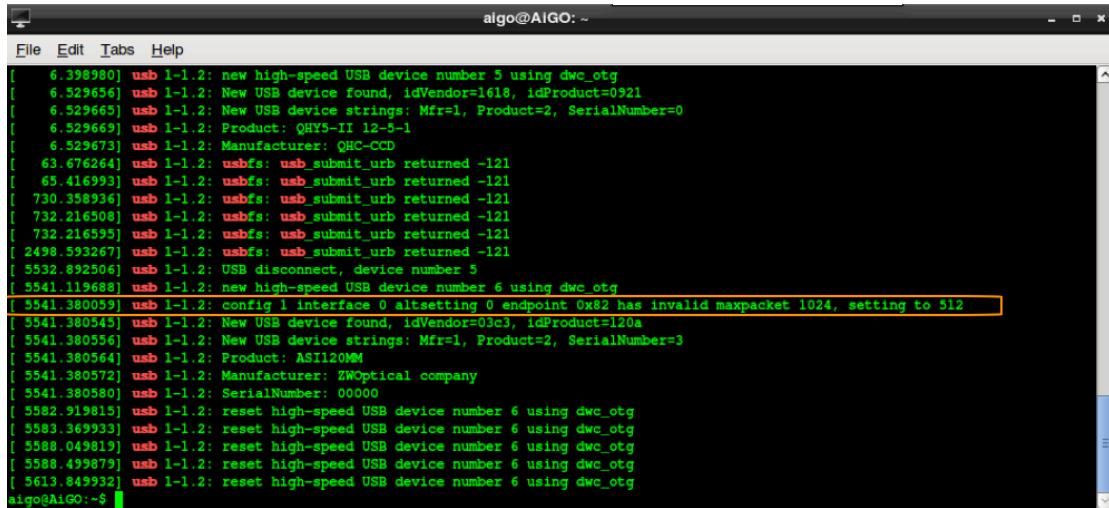
為解決 ASI120MM/MC 因為 USB 埠最大封包長度不合而導致 AiGO 導星派上無法擷取影像問題，此問題可透過更新 ASI120MM/MC 韌體來解決。

```
aigo@AiGO: ~
File Edit Tabs Help
[ 6.398980] usb 1-1.2: new high-speed USB device number 5 using dwc_otg
[ 6.529656] usb 1-1.2: New USB device found, idVendor=1618, idProduct=0921
[ 6.529665] usb 1-1.2: New USB device strings: Mfr=1, Product=2, SerialNumber=0
[ 6.529669] usb 1-1.2: Product: QHY5-II 12-51
[ 6.529673] usb 1-1.2: Manufacturer: QHY-CCD
[ 63.676264] usb 1-1.2: usbfis: usb_submit_urb returned -121
[ 65.416993] usb 1-1.2: usbfis: usb_submit_urb returned -121
[ 730.358936] usb 1-1.2: usbfis: usb_submit_urb returned -121
[ 732.216508] usb 1-1.2: usbfis: usb_submit_urb returned -121
[ 732.216595] usb 1-1.2: usbfis: usb_submit_urb returned -121
[ 2498.593267] usb 1-1.2: usbfis: usb_submit_urb returned -121
[ 5532.892506] usb disconnect, device number 5
[ 5541.119688] usb 1-1.2: new high-speed USB device number 6 using dwc_otg
[ 5541.380059] usb 1-1.2: config 1 interface 0 altsetting 0 endpoint 0x82 has invalid maxpacket 1024, setting to 512

[ 5541.380545] usb 1-1.2: New USB device found, idVendor=03c3, idProduct=120a
[ 5541.380556] usb 1-1.2: New USB device strings: Mfr=1, Product=2, SerialNumber=3
[ 5541.380564] usb 1-1.2: Product: ASI120MM
[ 5541.380572] usb 1-1.2: Manufacturer: ZWOptical company
[ 5541.380580] usb 1-1.2: SerialNumber: 00000
[ 5582.919815] usb 1-1.2: reset high-speed USB device number 6 using dwc_otg
[ 5583.369933] usb 1-1.2: reset high-speed USB device number 6 using dwc_otg
[ 5588.049819] usb 1-1.2: reset high-speed USB device number 6 using dwc_otg
[ 5588.429879] usb 1-1.2: reset high-speed USB device number 6 using dwc_otg
[ 5613.849932] usb 1-1.2: reset high-speed USB device number 6 using dwc_otg
aigo@AiGO: ~ $
```

未更新韌體前，在 AiGO 開啟 x-Terminal，輸入 `dmesg | grep usb` 可見到，**config 1 interface 0 altsetting 0 endpoint 0x82 has invalid maxpacket 1024, setting to 512** 訊息，在此情況下導能導致導星軟體閃退或無法擷取影像；升級完韌體後，即可解決此問題；

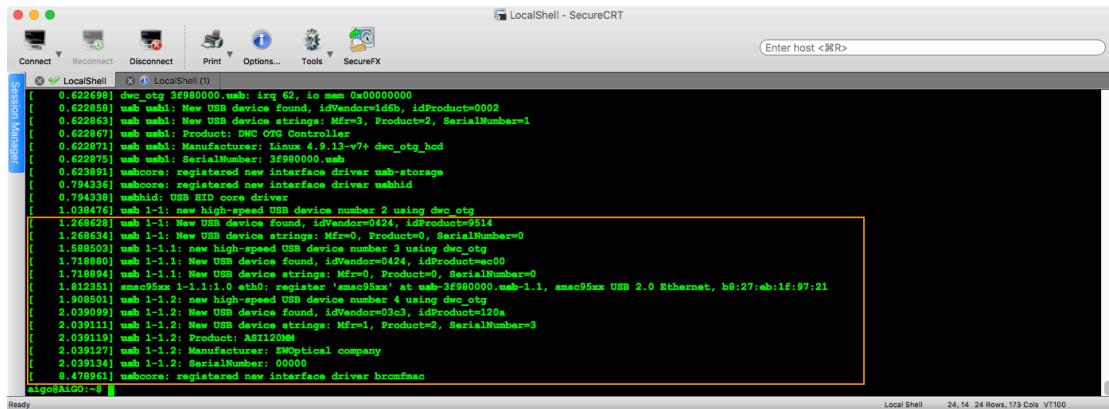
```
LocalShell - SecureCRT
Enter host <36R>
[ 0.622698] dwc_otg 36980000.usb: irq 62, io mem 0x00000000
[ 0.622858] usb usb1: New USB device found, idVendor=1d6b, idProduct=0002
[ 0.622863] usb usb1: New USB device strings: Mfr=3, Product=2, SerialNumber=1
[ 0.622867] usb usb1: Product: DWC OTG Controller
[ 0.622871] usb usb1: Manufacturer: Linux 4.9.13-v7+ dwc_otg_hcd
[ 0.622875] usb usb1: SerialNumber: 3E980000.usb
[ 0.623891] uehcobus: registered new interface driver uehc-storage
[ 0.794336] uehcobus: registered new interface driver uehchid
[ 0.794338] uehchid: USB HID core drivers
[ 1.030476] uehcobus: registered new high-speed USB device number 2 using dwc_otg
[ 1.260634] uehcobus: found new high-speed USB device at 0x0424, idVendor=03c3, idProduct=9514
[ 1.260634] uehcobus: uehc 1-1: New USB device found, idVendor=03c3, idProduct=9514, SerialNumber=0
[ 1.598503] uehcobus: uehc 1-1.1: new high-speed USB device number 3 using dwc_otg

[ 1.719889] uehcobus: uehc 1-1.1: New USB device found, idVendor=0424, idProduct=<c>0
[ 1.719889] uehcobus: uehc 1-1.1: New USB device strings: Mfr=0, Product=0, SerialNumber=0
[ 1.812351] smsc95xx 1-1.1:1.0 eth0: register 'smsc95xx' at uehc-3E980000.usb-1.1, smsc95xx UBB 2.0 Ethernet, h8:27:eb:1f:97:21
[ 1.908501] uehcobus: uehc 1-1.2: new high-speed USB device number 4 using dwc_otg
[ 2.039099] uehcobus: uehc 1-1.2: New USB device found, idVendor=03c3, idProduct=120a
[ 2.039119] uehcobus: uehc 1-1.2: New USB device strings: Mfr=1, Product=2, SerialNumber=3
[ 2.039119] uehcobus: uehc 1-1.2: Product: ASI120MM
[ 2.039127] uehcobus: uehc 1-1.2: Manufacturer: ZWOptical company
[ 2.039127] uehcobus: uehc 1-1.2: SerialNumber: 00000
[ 2.478961] uehcobus: registered new interface driver brcmfmac
aigo@AiGO: ~ $
```
