AiGO Field Notes 2017-03-11

如何更新 ASI 034, ASI120MM/MC 韌體

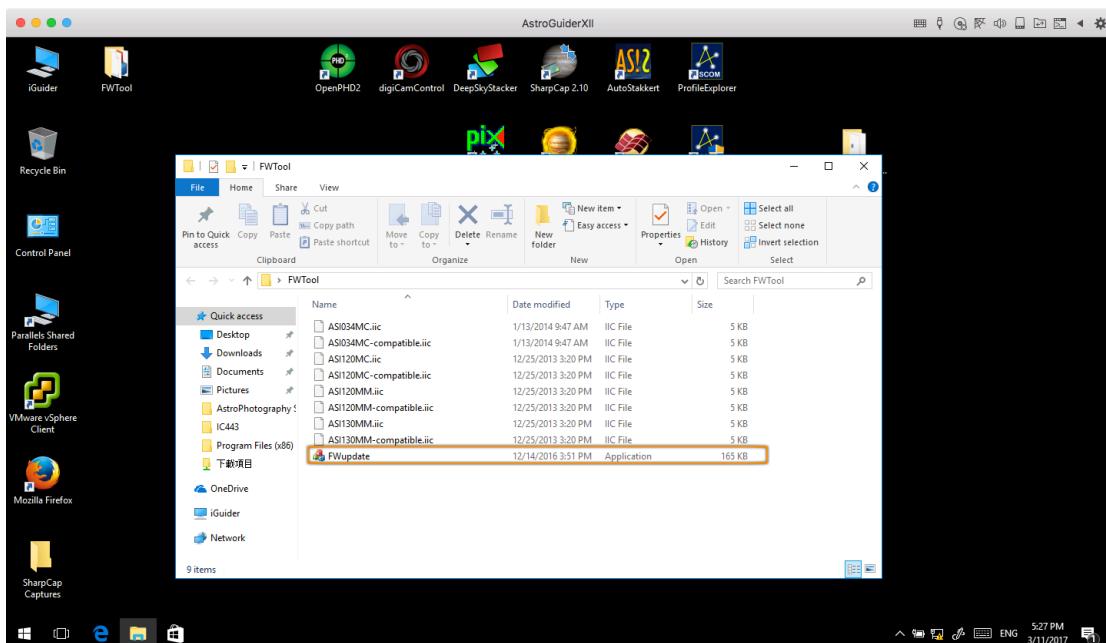
(3) 將 ASI120MM/MC CCD 連接到電腦上，然後執行 **FWUpgradeTool** 執行檔

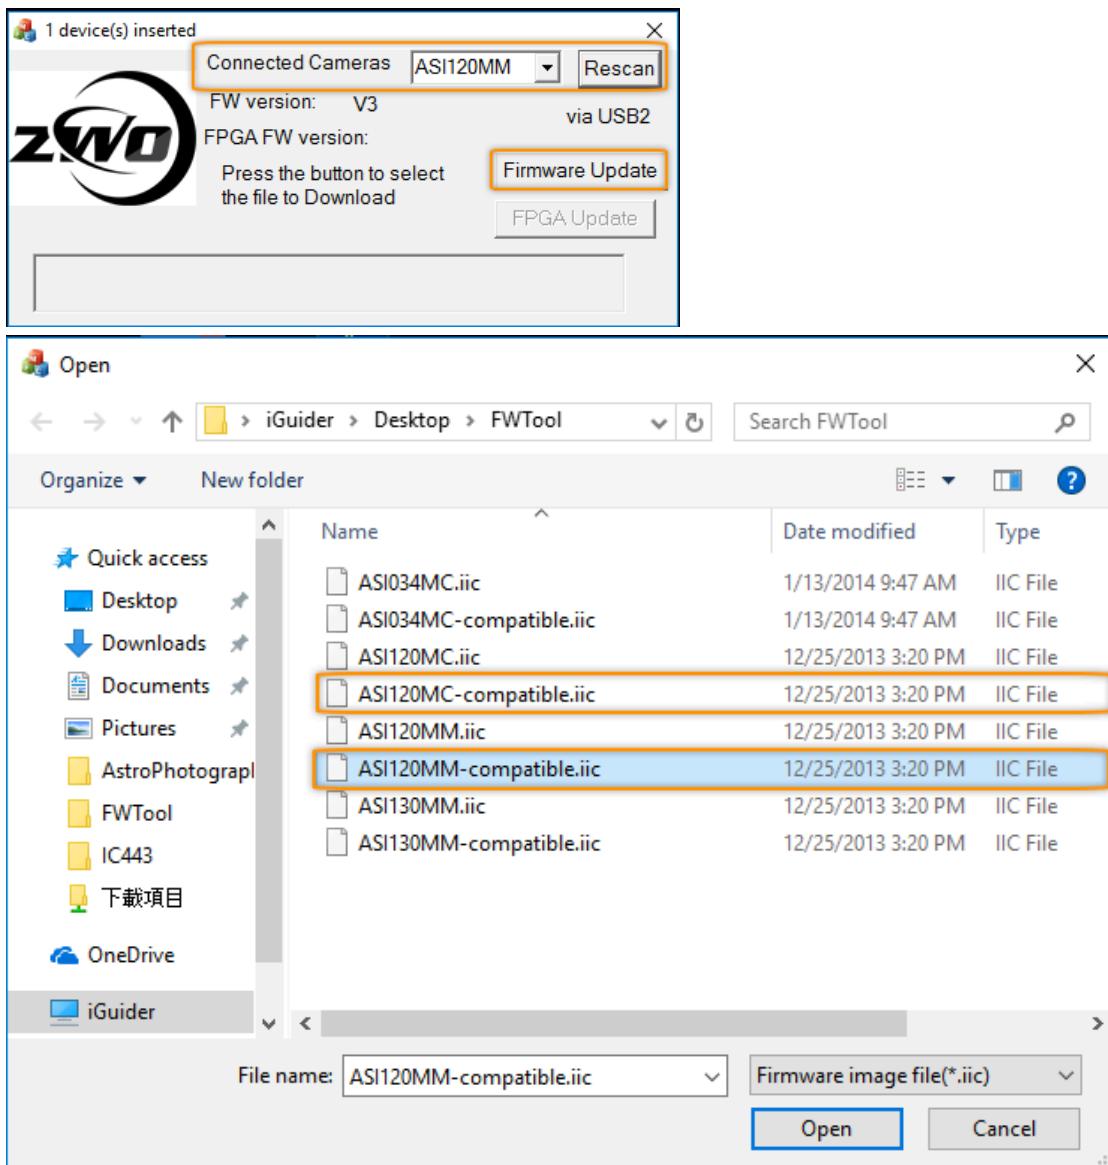
(4) 如果 CCD 連接成功，你會在 **FWUpgradeTool** 上見到該 CCD 的型號和目前韌體的版本；點擊 **[Firmware Upgrade]** 圖框，並選取相對應的韌體檔 **ASI120MC-compatible.iic (ASI120MC)** 或 **ASI120MM-compatible.iic** 後，點擊 **[Open]** 圖框

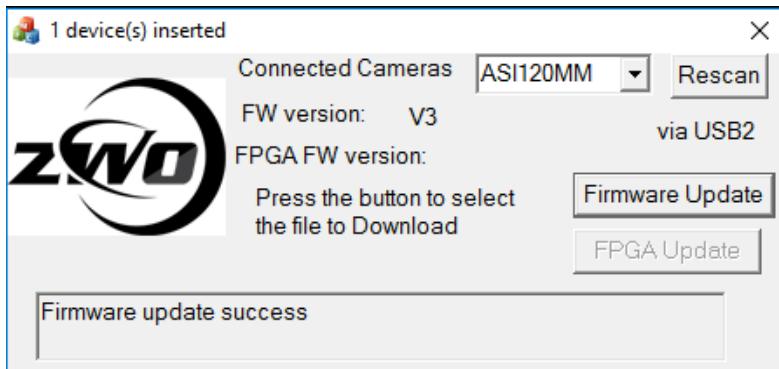
(5) 如果沒有任何問題，畫面上會顯示 “*Downloading firmware*”->”*Firmware update success*” 訊息，此時即可退出該程式，並退出 CCD。

* **compatible** 版本韌體執行效能較差，如果此 CCD 僅使用於導星用途，則後續不需要在做任何處置，如果後續想利用於行星、太陽、月面等高速錄影的環境，可以再恢復一般韌體版本。
